# Accidental Mixing: Dangers, Incidents, and Prevention

Robyn Brooks

October 14, 2025

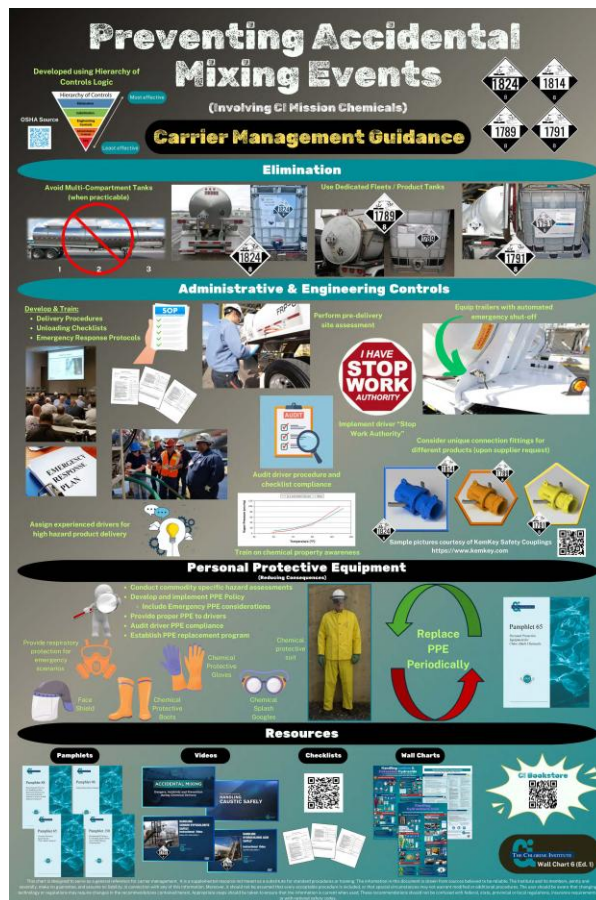
## Wall Chart 6

- Wall Chart 6) Preventing Accidental Mixing Events [Driver/Carrier Focus]
- Wall Chart 7) Preventing Accidental Mixing Events [Customer Focus]
- Double-sided charts detail both manager and driver/operator best practices

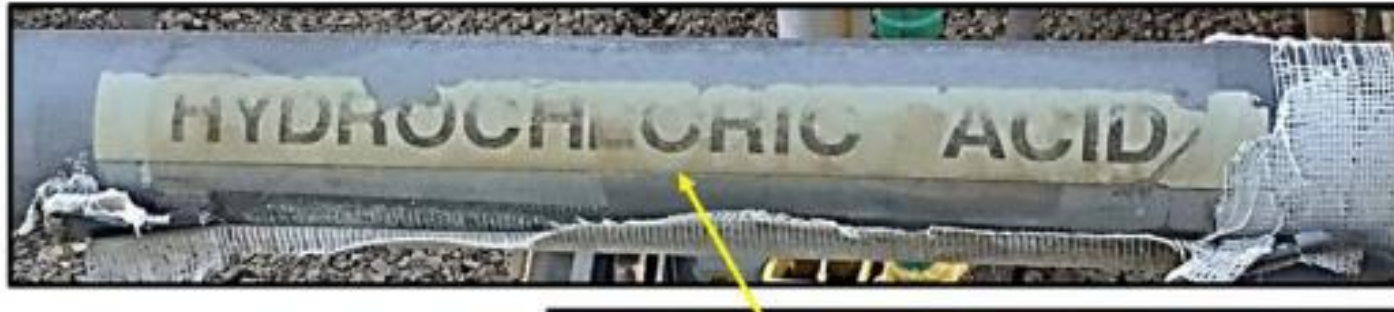
- Storage tanks, fill lines, or connections not labeled/marked correctly or marked at all

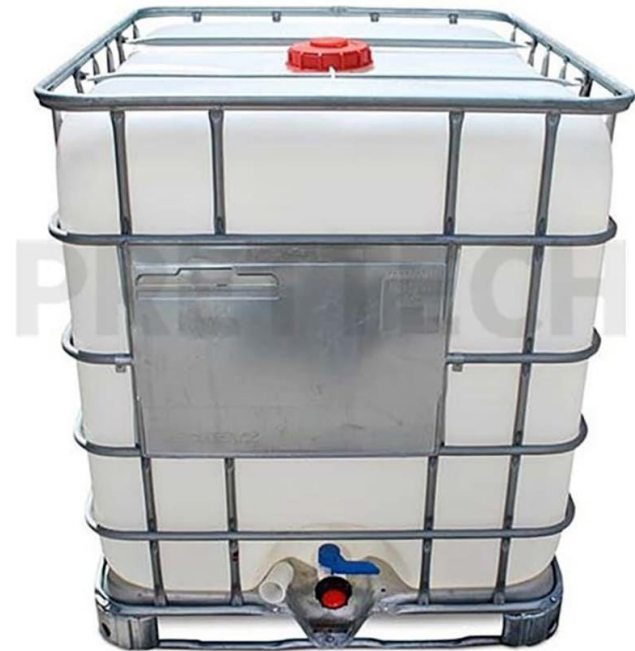
- Not having dedicated pumps for different products (mini-bulk delivery)

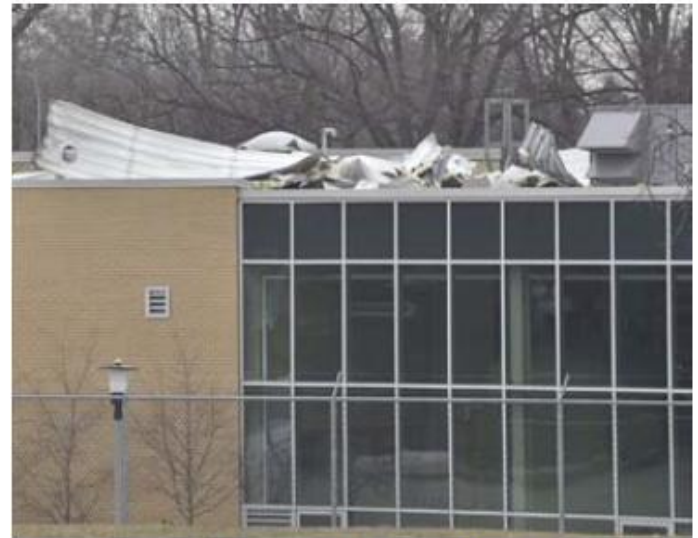
- April 2, 2014, a driver was scheduled to deliver ammonium sulfate to an unstaffed water treatment facility in Kitchener, Ontario
- The ammonium sulfate is accidentally delivered into a sodium hypochlorite tank
- The reaction is so violent, there is damage to the roof of the multi-story building

*Damage to the roof of the Greenbrook Pumping Station can be seen Thursday, the day after an explosion there.*

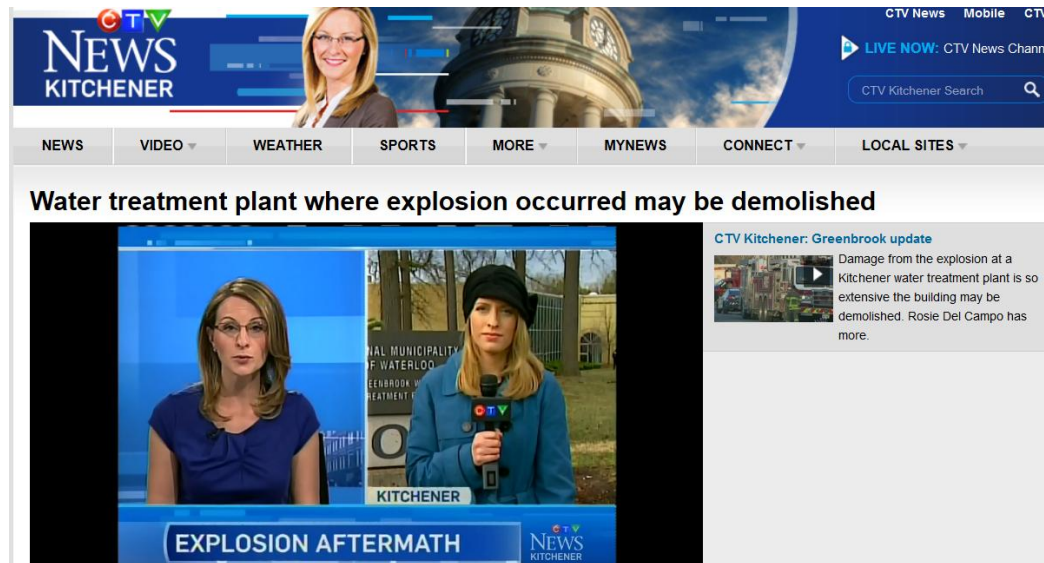
## Sodium Hypochlorite + Ammonium Sulfate

- The incident receives multi-day news coverage
- 12 days after the incident, there is speculation that the building will need to be demolished due to structural issues
